## Bodyshell

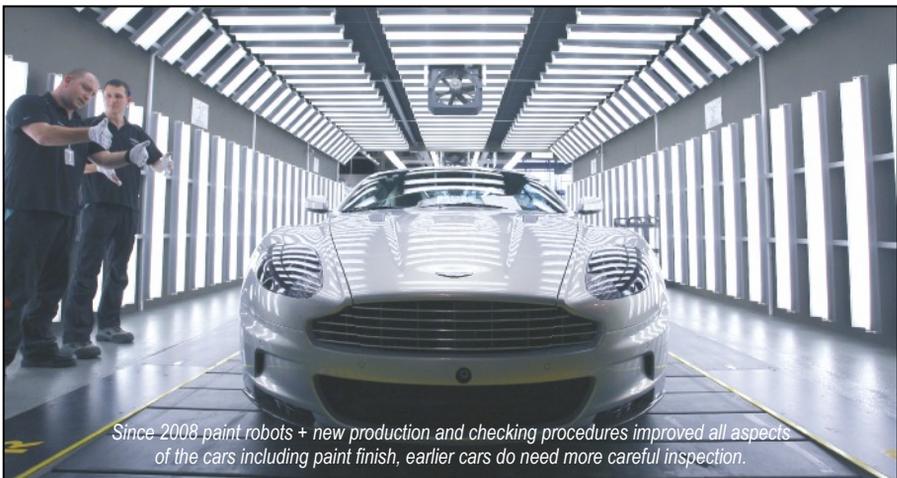
*Since 2008 paint robots + new production and checking procedures improved all aspects of the cars including paint finish, earlier cars do need more careful inspection.*

The latest generation of Aston Martin has been built to a high standard throughout and if properly looked after should be clean and tidy even if they are high mileage. Some earlier cars did have a reputation for patchy paint quality and can be more prone to stone chips. This means the overall paintwork does need careful inspection for inconsistencies, orange peel effects excess marking and wear. The overall quality seems to have improved each year, and from mid-2008 onwards new paint techniques and inspection checks further improved consistency for the already high-quality hand finish.
